From: Spektrum Signal [webmaster@spektrumrc.com]
Sent: Tuesday, October 20, 2009 3:00 AM
To: Carmen Grosse
Subject: DX6i Trainer Jack Bulletin

If you own a DX6i transmitter that has Product Identification Codes (PIDs) HA906X and HA907X, then please read the following advisory.

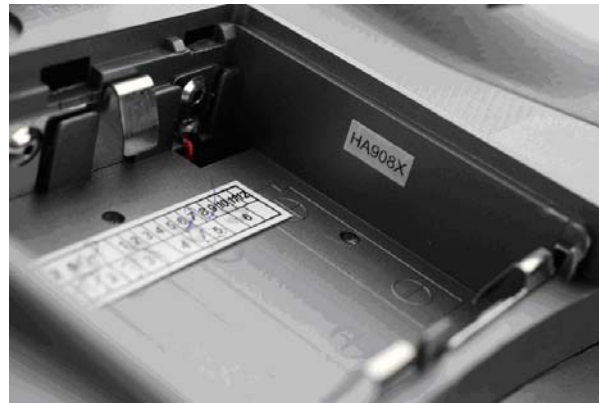
Product Identification (PID) code may be found on the inside of the battery compartment of the DX6i transmitter.

PID within the battery compartment

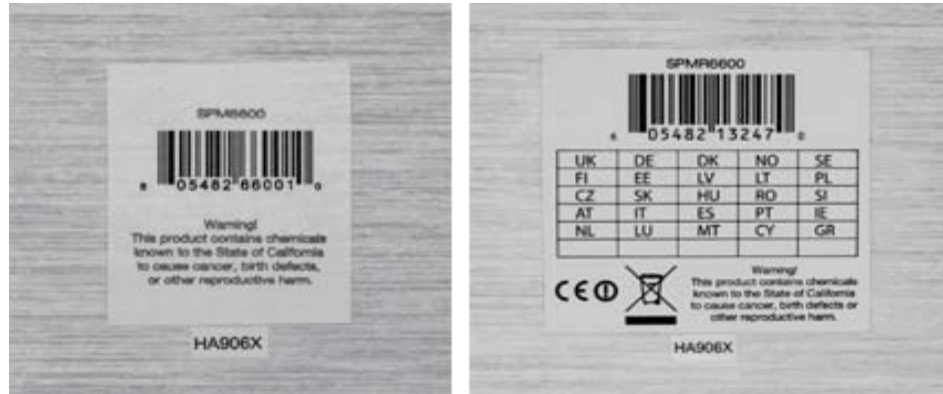
PID on the DX6i box (beneath the UPC)
